About a CLOAC (ID=351) problem

We cannot take data, when we use CLOAC II (ID=351).

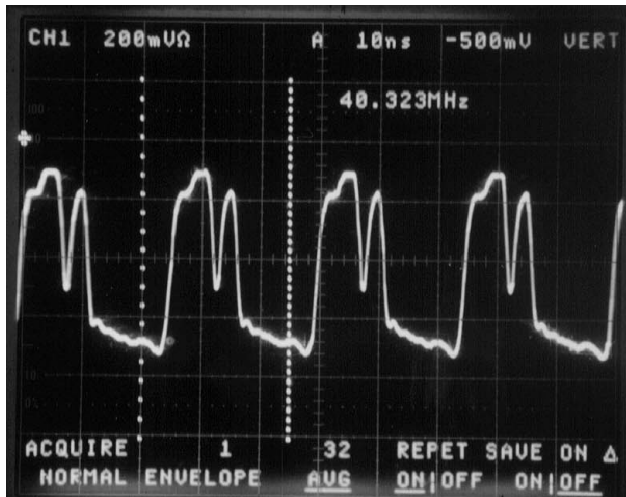
An output signal from CLK0 on the front panel of CLOAC shows a strange pulse shape (Fig.1), compared with good one (Fig.2).

Fig.1 Pulse shape of CLK0 (ID=351)

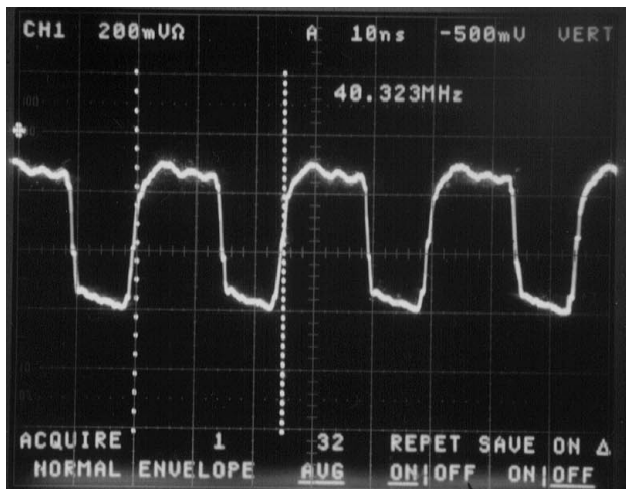
Fig.2 Pulse shape of CLK0 (ID=316: good CLOAC)

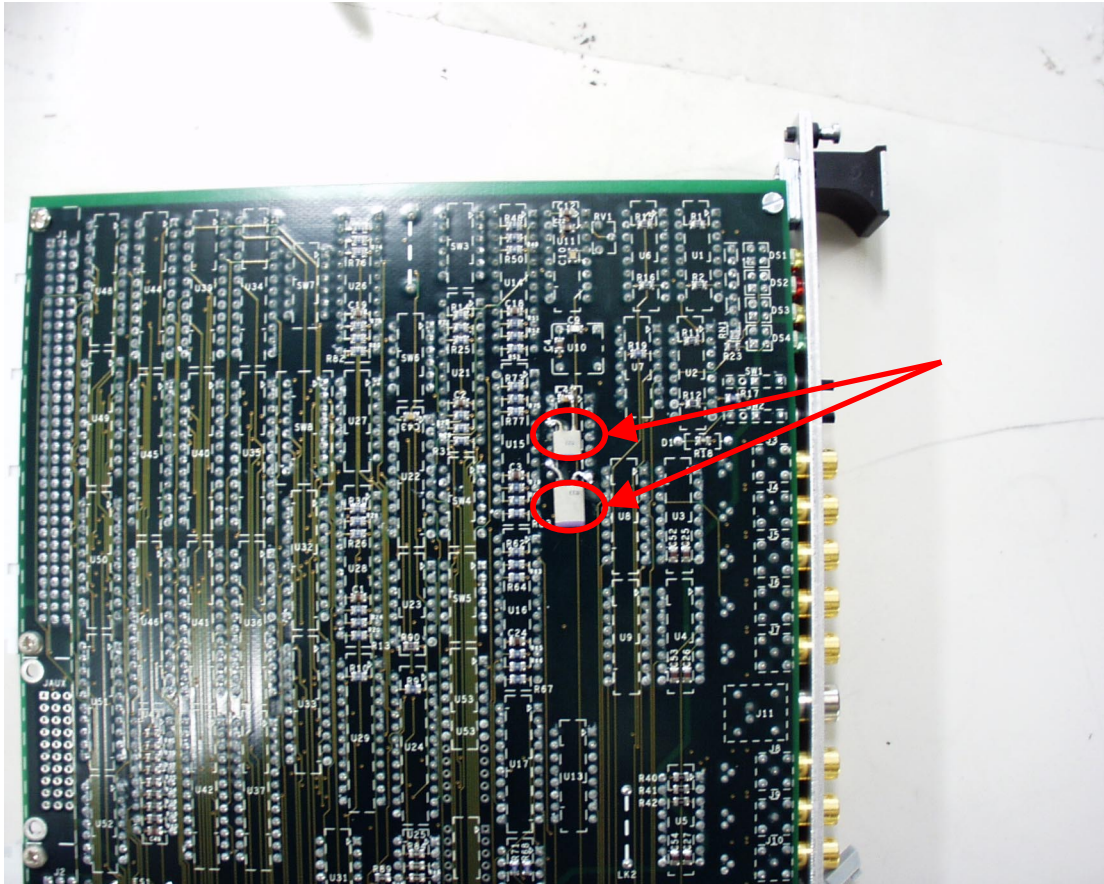
Two ad hoc ceramic capacitors are soldered on the backside of U12 (74ABT74N), 10pin-GND and 13pin-GND, for bad CLOAC (Fig.3). But there are no ad hoc capacitors for good CLOAC.

Fig3. Ad hoc capacitors
